EXPLOSION AT CONSOLIDATED SCHOOL
NEW LONDON, TEX.

INVESTIGATION OF EXPLOSION AT
CONSOLIDATED SCHOOL, NEW LONDON, TEX.

MARCH 18, 1937

Prepared by
DAVID J. PRICE
Principal Engineer in Charge
Chemical Engineering Research Division
Bureau of Chemistry and Soils
U. S. Department of Agriculture
Washington, D. C.

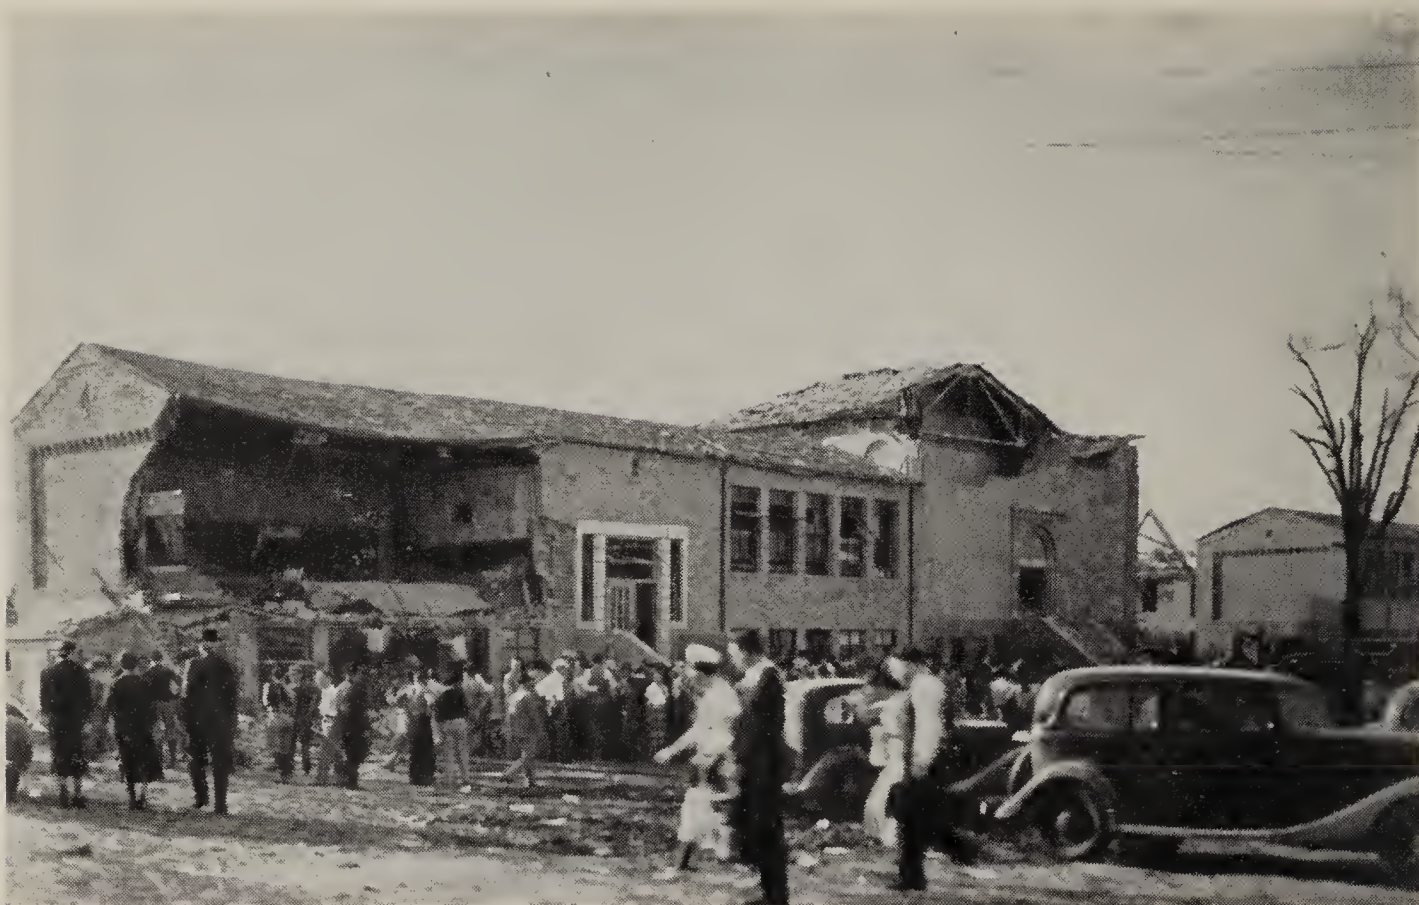
View of graded school and auditorium after explosion on March 18, 1937; approximately 300 children were killed in this section of the building.

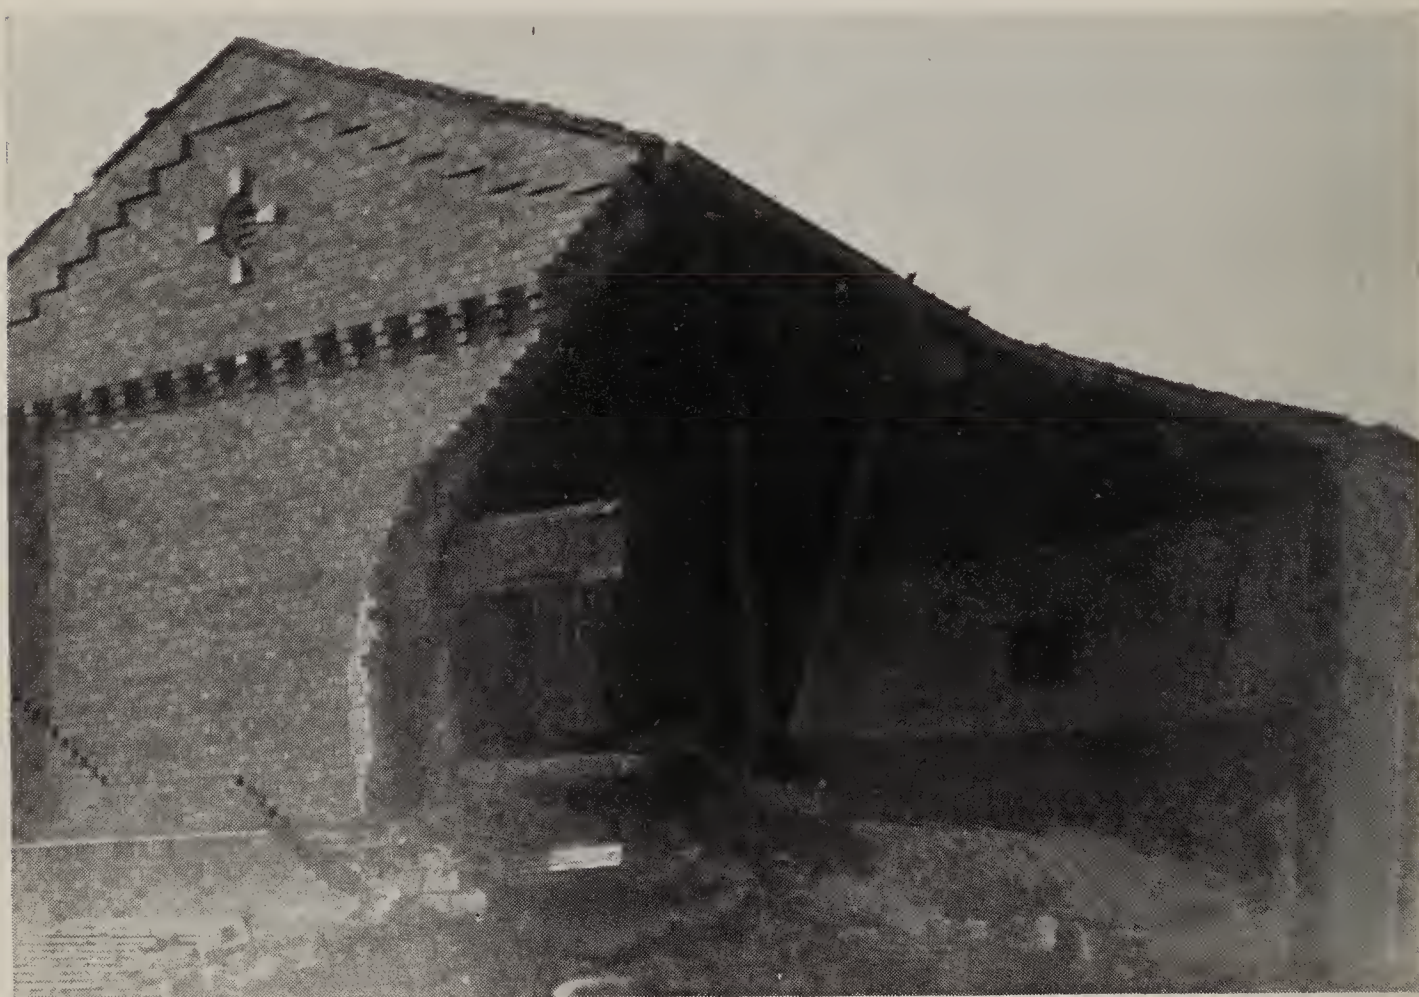
Close-up view of second floor of graded school at southeast corner of building.

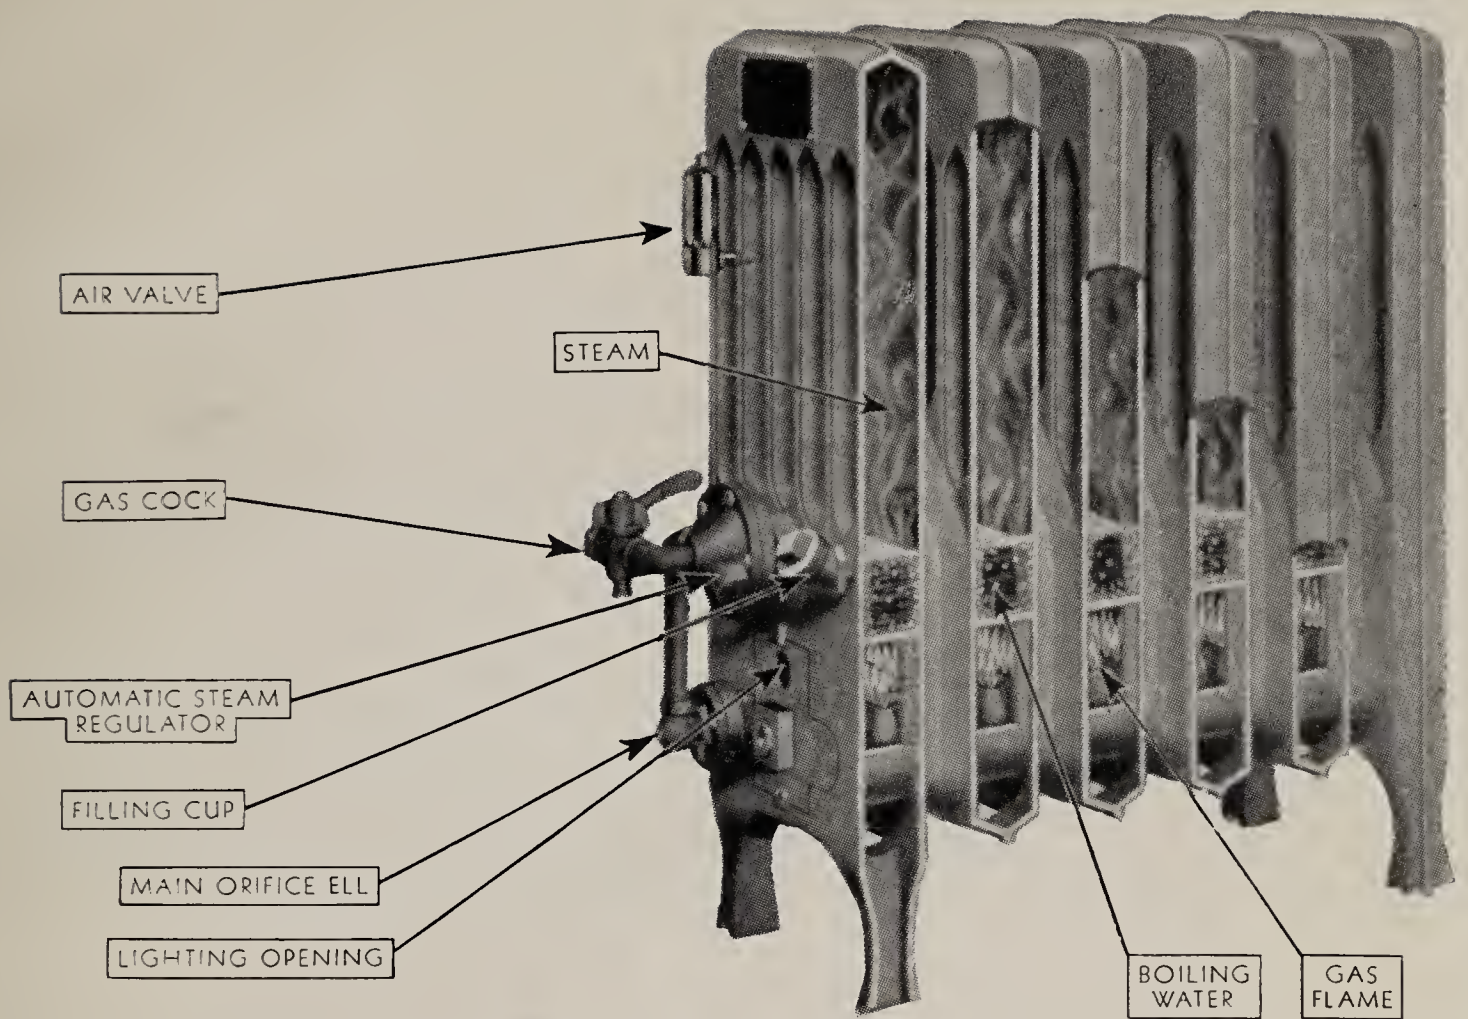
FIGURE 3.—Gasteam radiator.

The operation of a "Gasteam" radiator is illustrated in figure 3. The upper portion forms the steam-heating surface; the lower portion forms a water compartment and combustion chamber which encloses the gas burner. A steam-pressure regulator so operates that when the gas is first lighted a maximum volume of gas is burned to generate

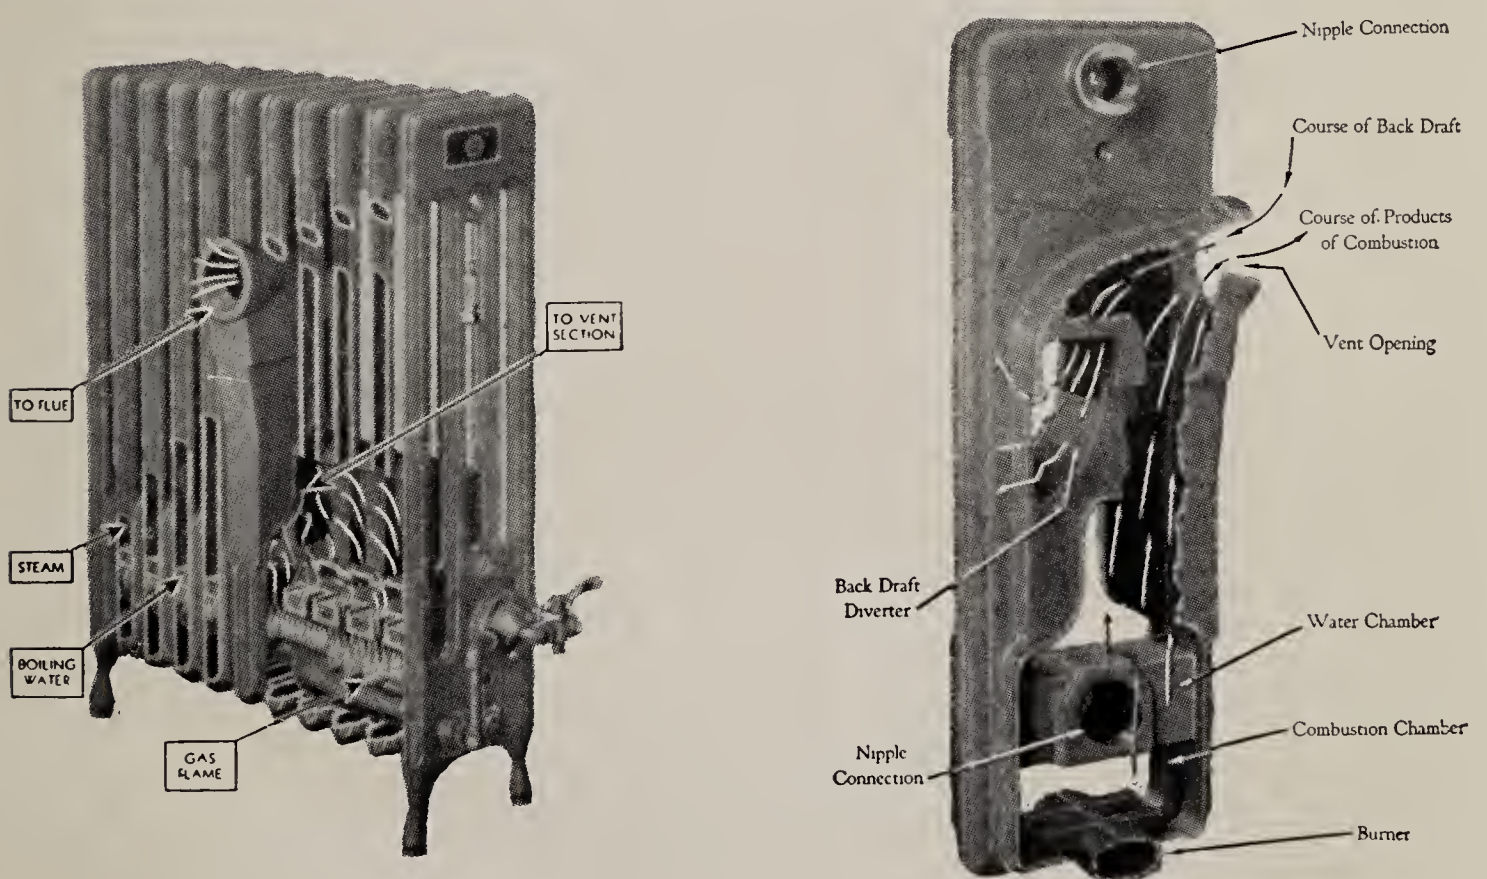
FIGURE 4.—Vented gasteam radiator.

Figure 4 shows a vented "Gasteam" radiator. In discussing the application of vented and unvented "Gasteam" radiators the manufacturing company states:

With vented "Gasteam" radiators the moisture produced by the burning of fuel gas is carried to the outside of the building through vent stacks. When all vented "Gasteam" radiators are used on an installation, there is no humidity from the radiators added to the heated room air, and a very dry condition results.

In addition to the vented radiators carrying off the products of combustion, many engineers feel that they are also desirable and essential to provide a means of escape to outside air of any unconsumed gas that may escape from the burner at the base of the radiator. This precaution is considered essential by the advocates of vented radiator installations to protect against the possible accumulation of gas in the atmosphere of the room.

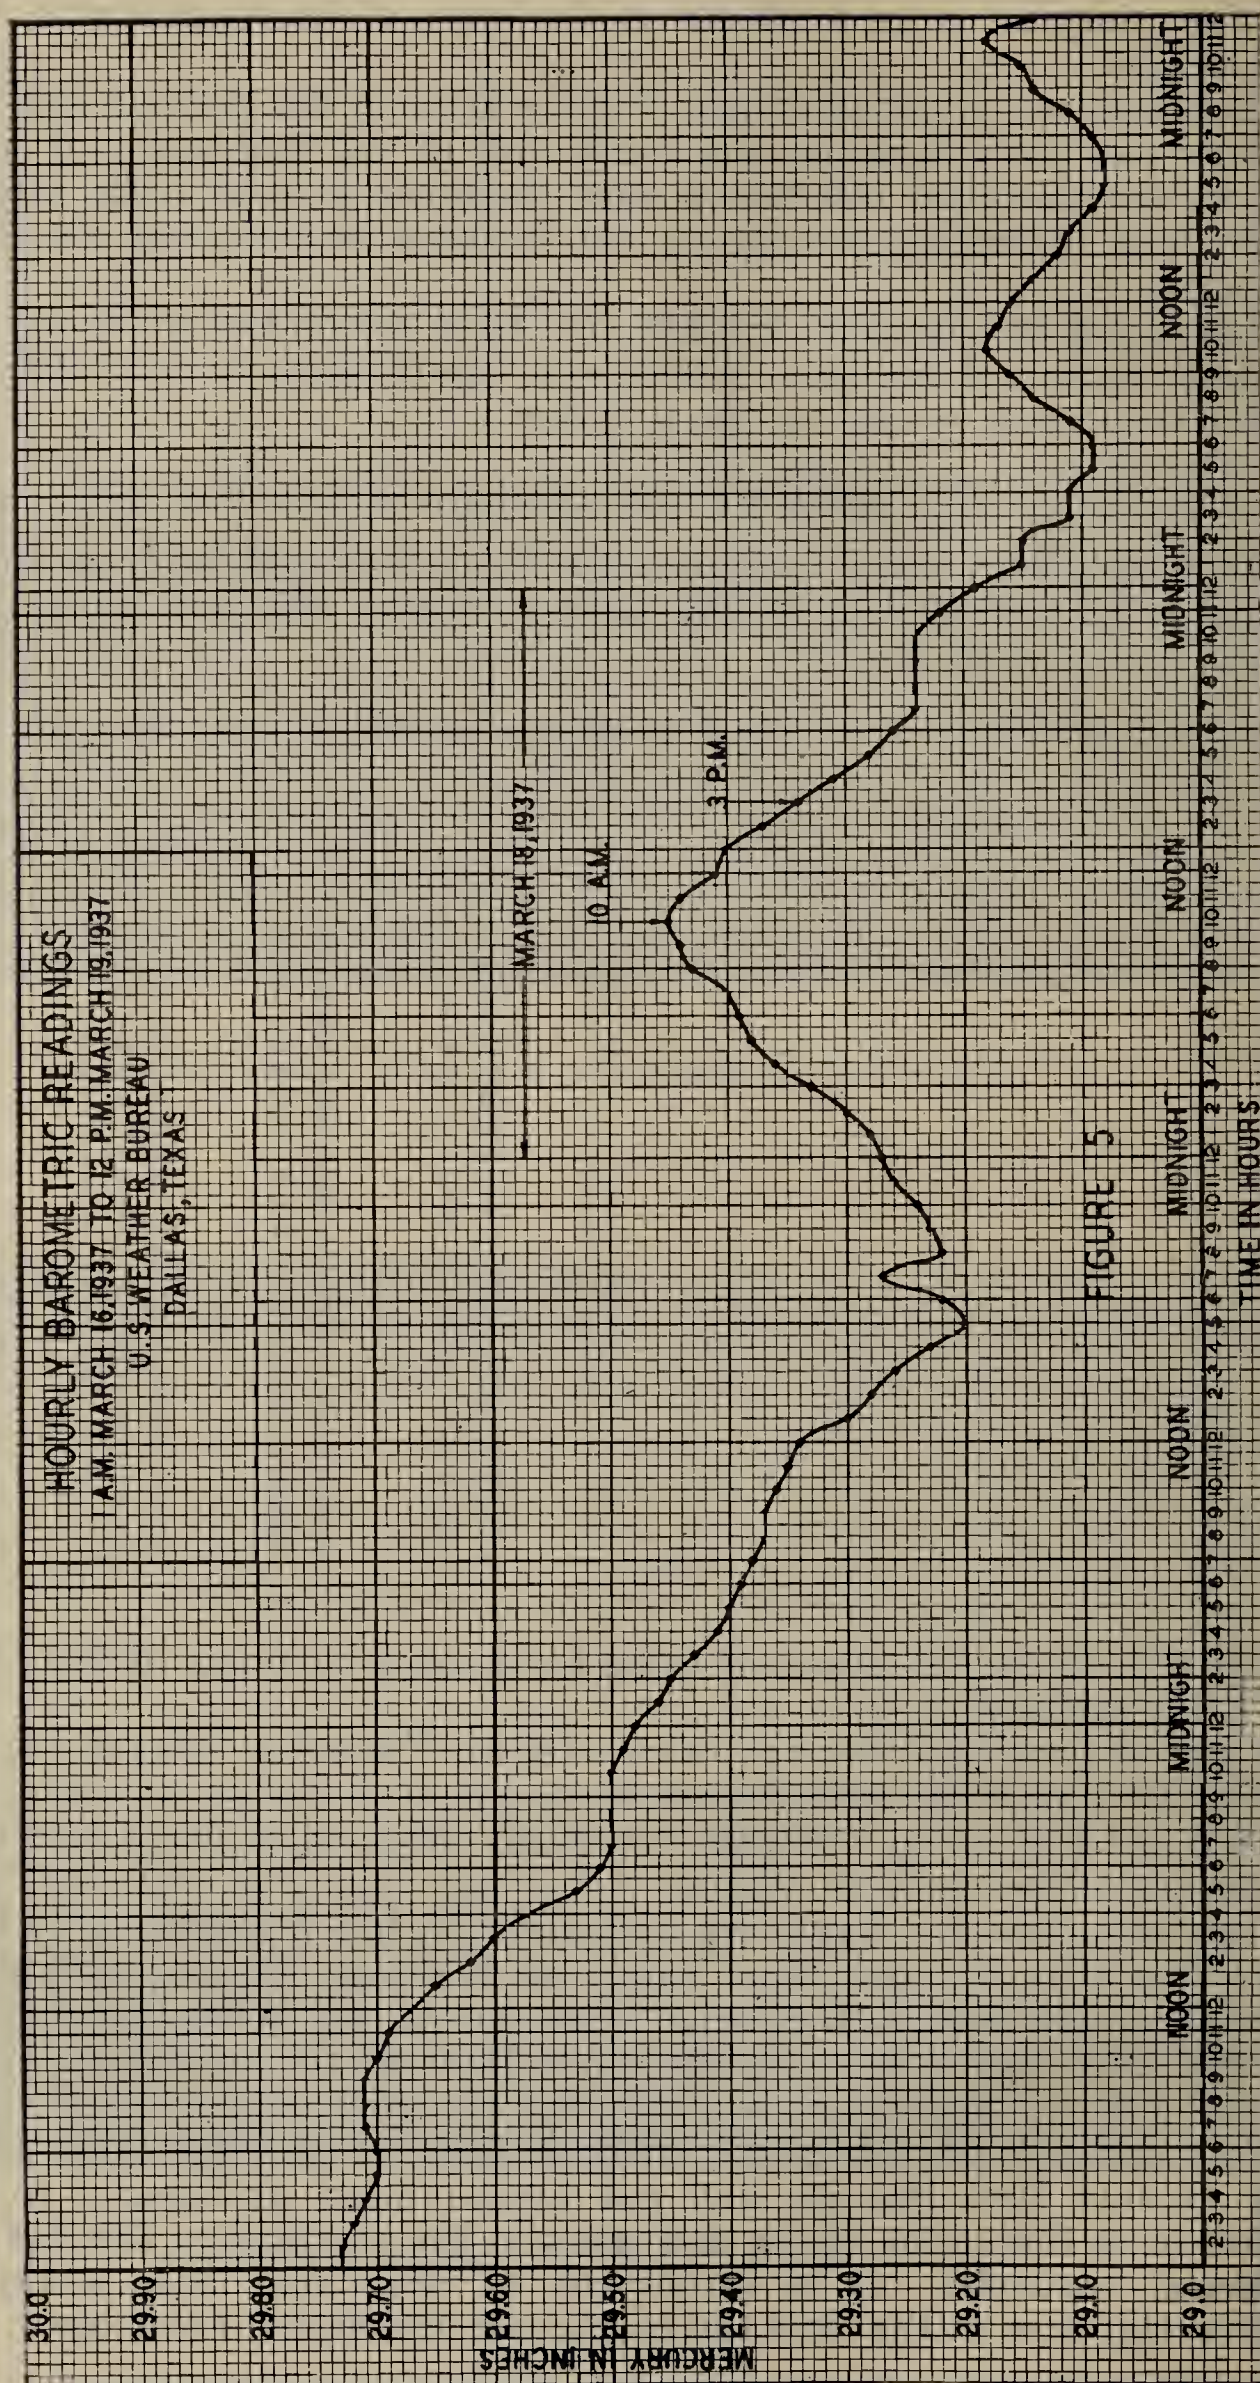
Figure 5 shows the graph of these barometric readings by hours for the 4-day period.

It will be observed that the barometer for Thursday, March 18, was high at 10 a. m. with a reading of 29.45 and that at 3 p. m.; about the time of the explosion, the barometer had dropped to 29.34 and continued to fall for some time later.

The fact that the explosion occurred during a period of falling barometer is important for at least two reasons. In the first place, it may explain how it happened that one of the school employees, entering the open area underneath the floor at the southeast corner about 10 a. m. to remove some stored material, was able to strike several matches at this point without causing an explosion. It is very evident that the gas had not accumulated sufficiently for an explosion at this point up to 10 o'clock in the morning of the day the explosion occurred. It is important to note that this workman entered this area at the time the barometer was high for the day.

In the second place the gas would probably escape more readily and therefore accumulate in larger quantities as the barometer was falling. It is quite likely therefore that during the 5 hours of falling barometer from 10 a. m. to 3 p. m., the approximate time of the explosion, a large amount of gas had collected in the open area under the first floor.

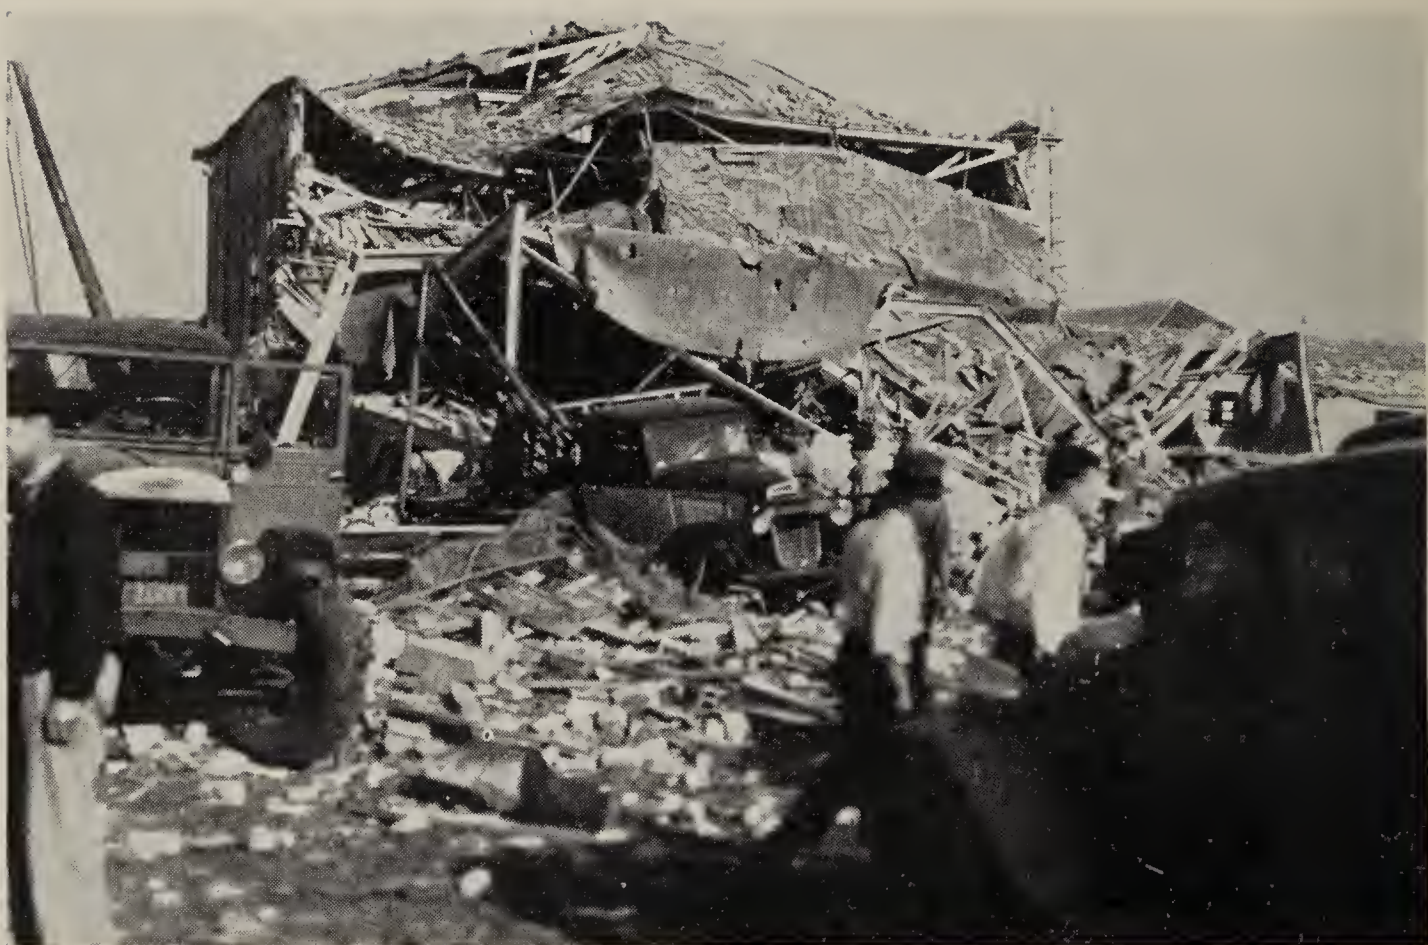
Another view of auditorium while recovery work was in progress. Many bodies were buried in the debris.

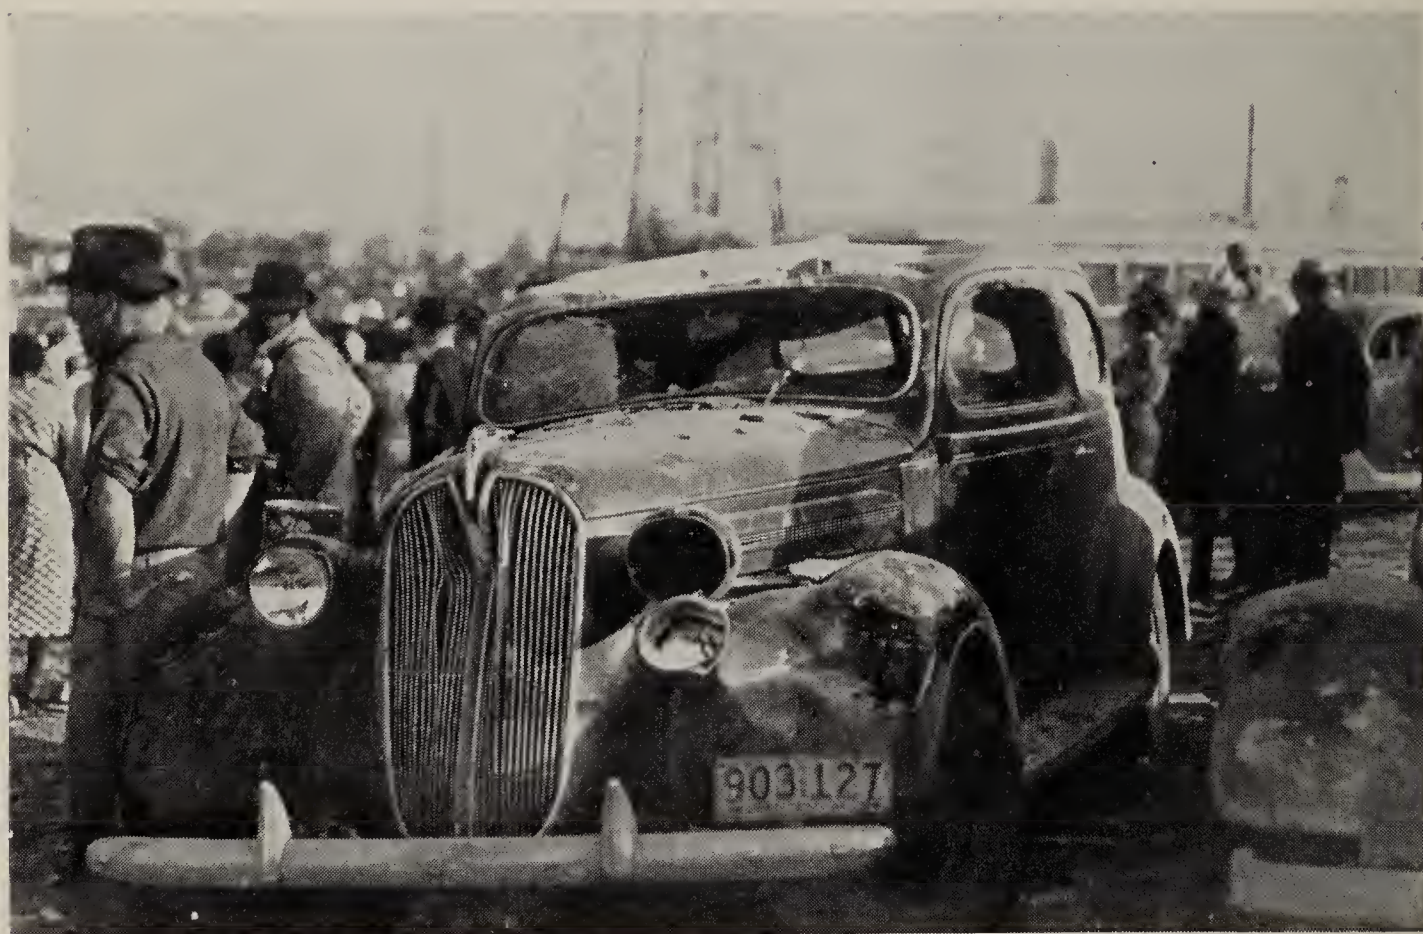
Damaged automobile parked about 125 feet from southeast corner of building.
